Subject: Vibration Impact Assessment
Tie Line 649 Wood to Steel Replacement Project
San Diego Gas & Electric Company
San Diego County, California
AECOM Reference No. 60597643

Photo Documentation
San Diego Gas and Electric - TL 649 Vibration Assessment
Chula Vista, California

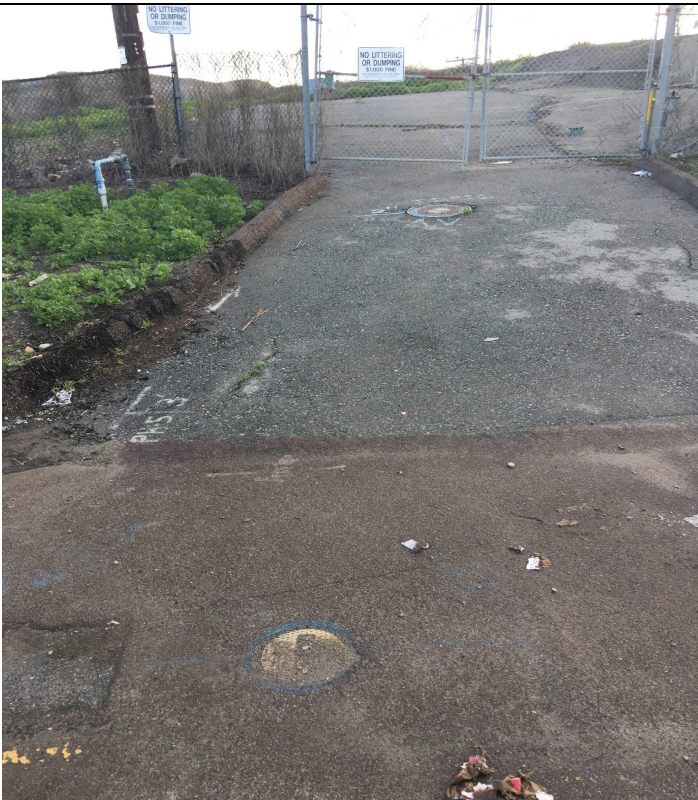
Utility mark out near Pole 18

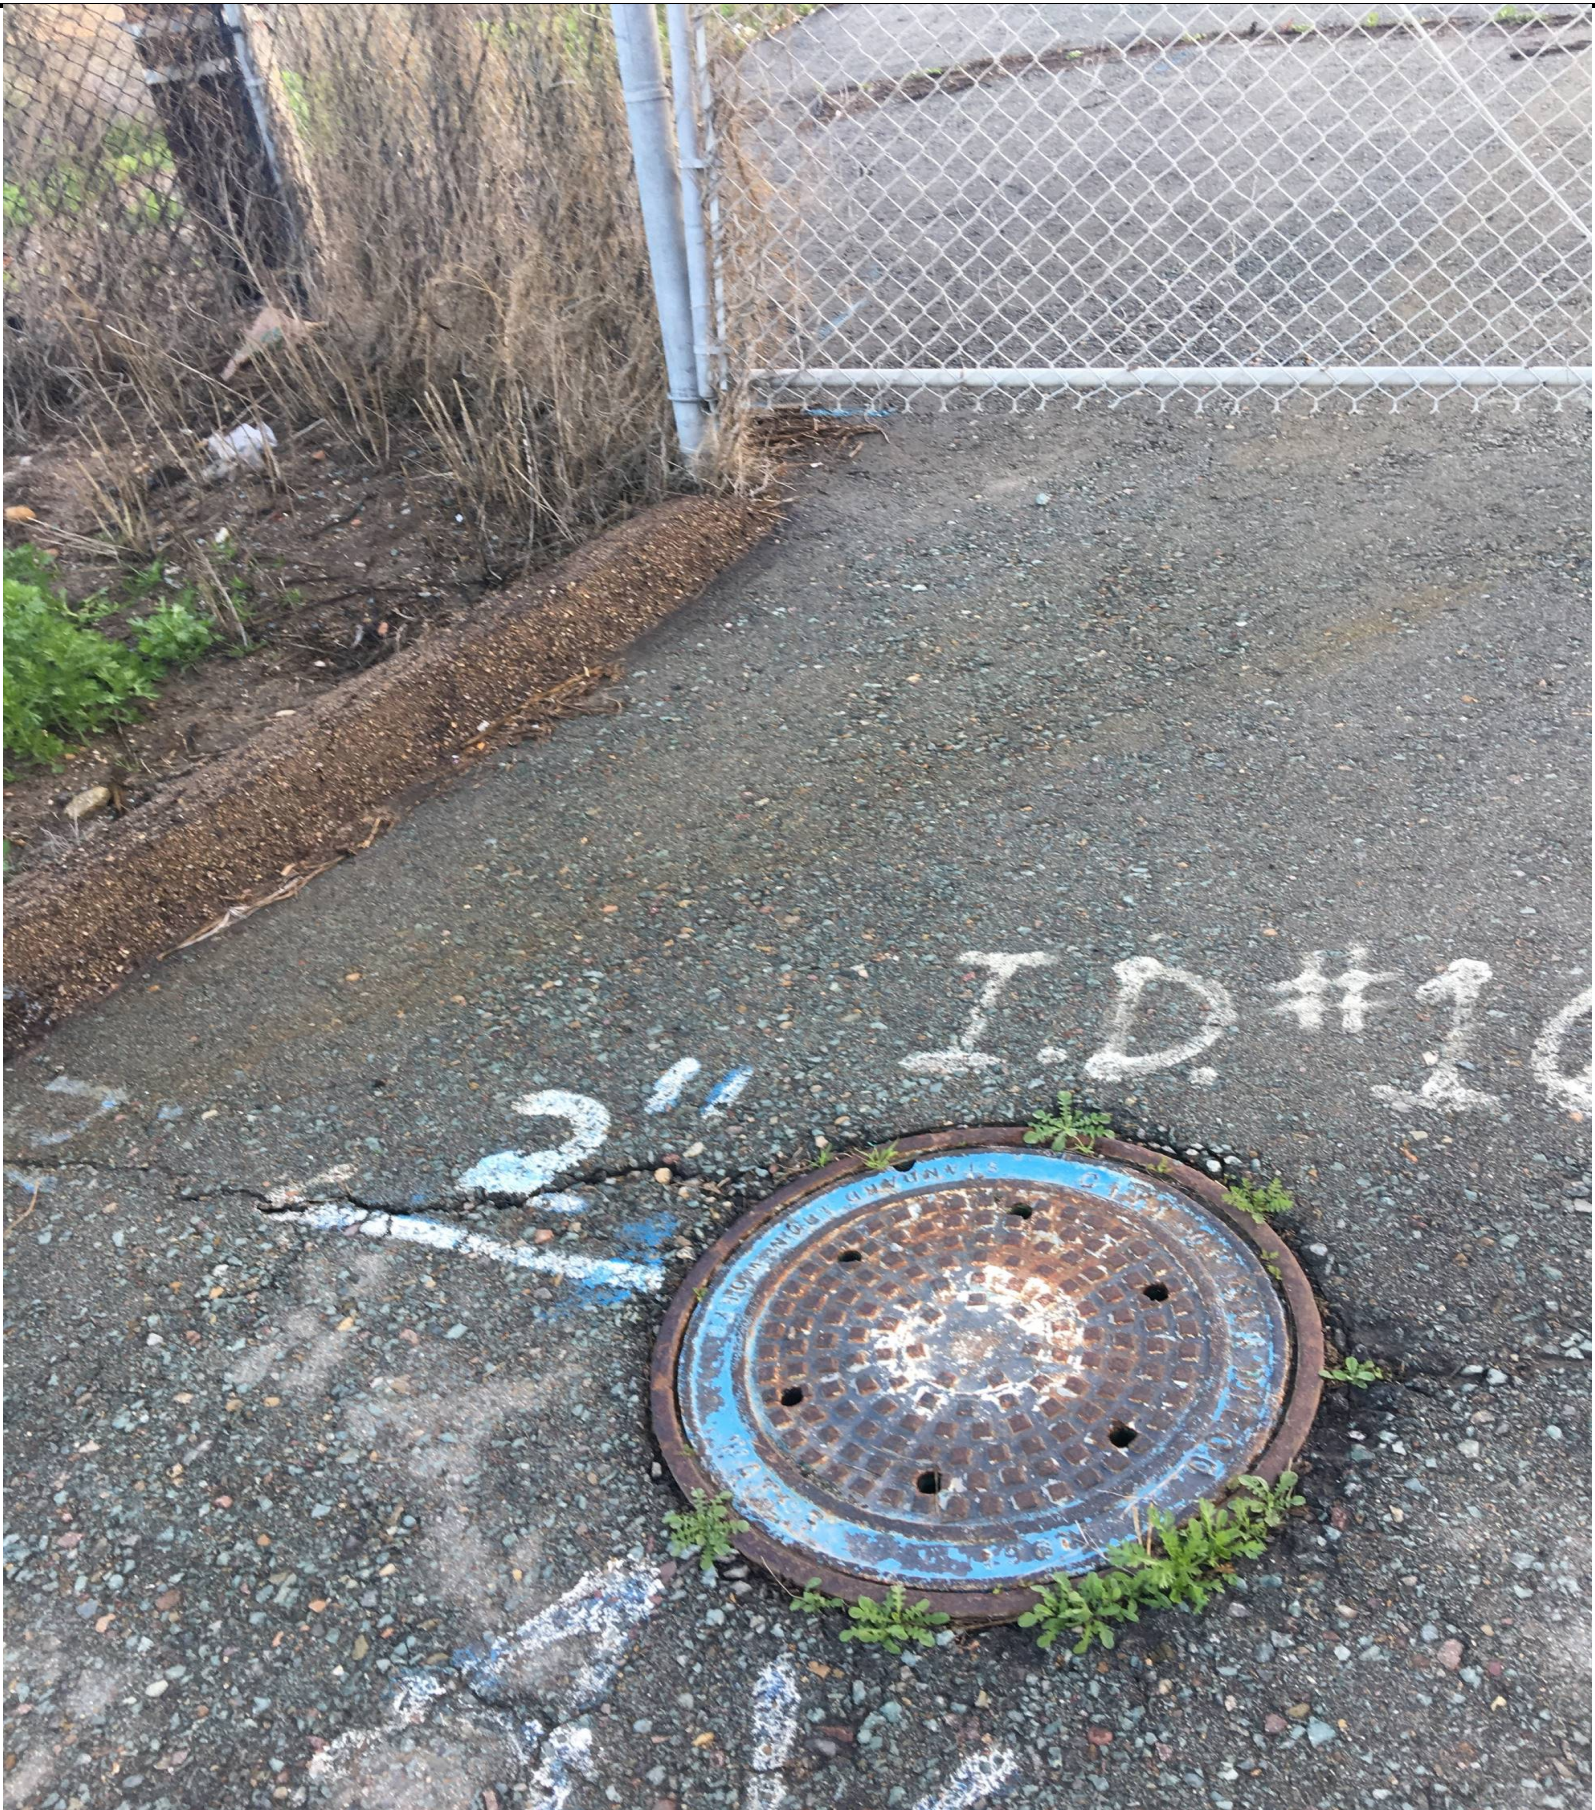
Utility mark out near Pole 18

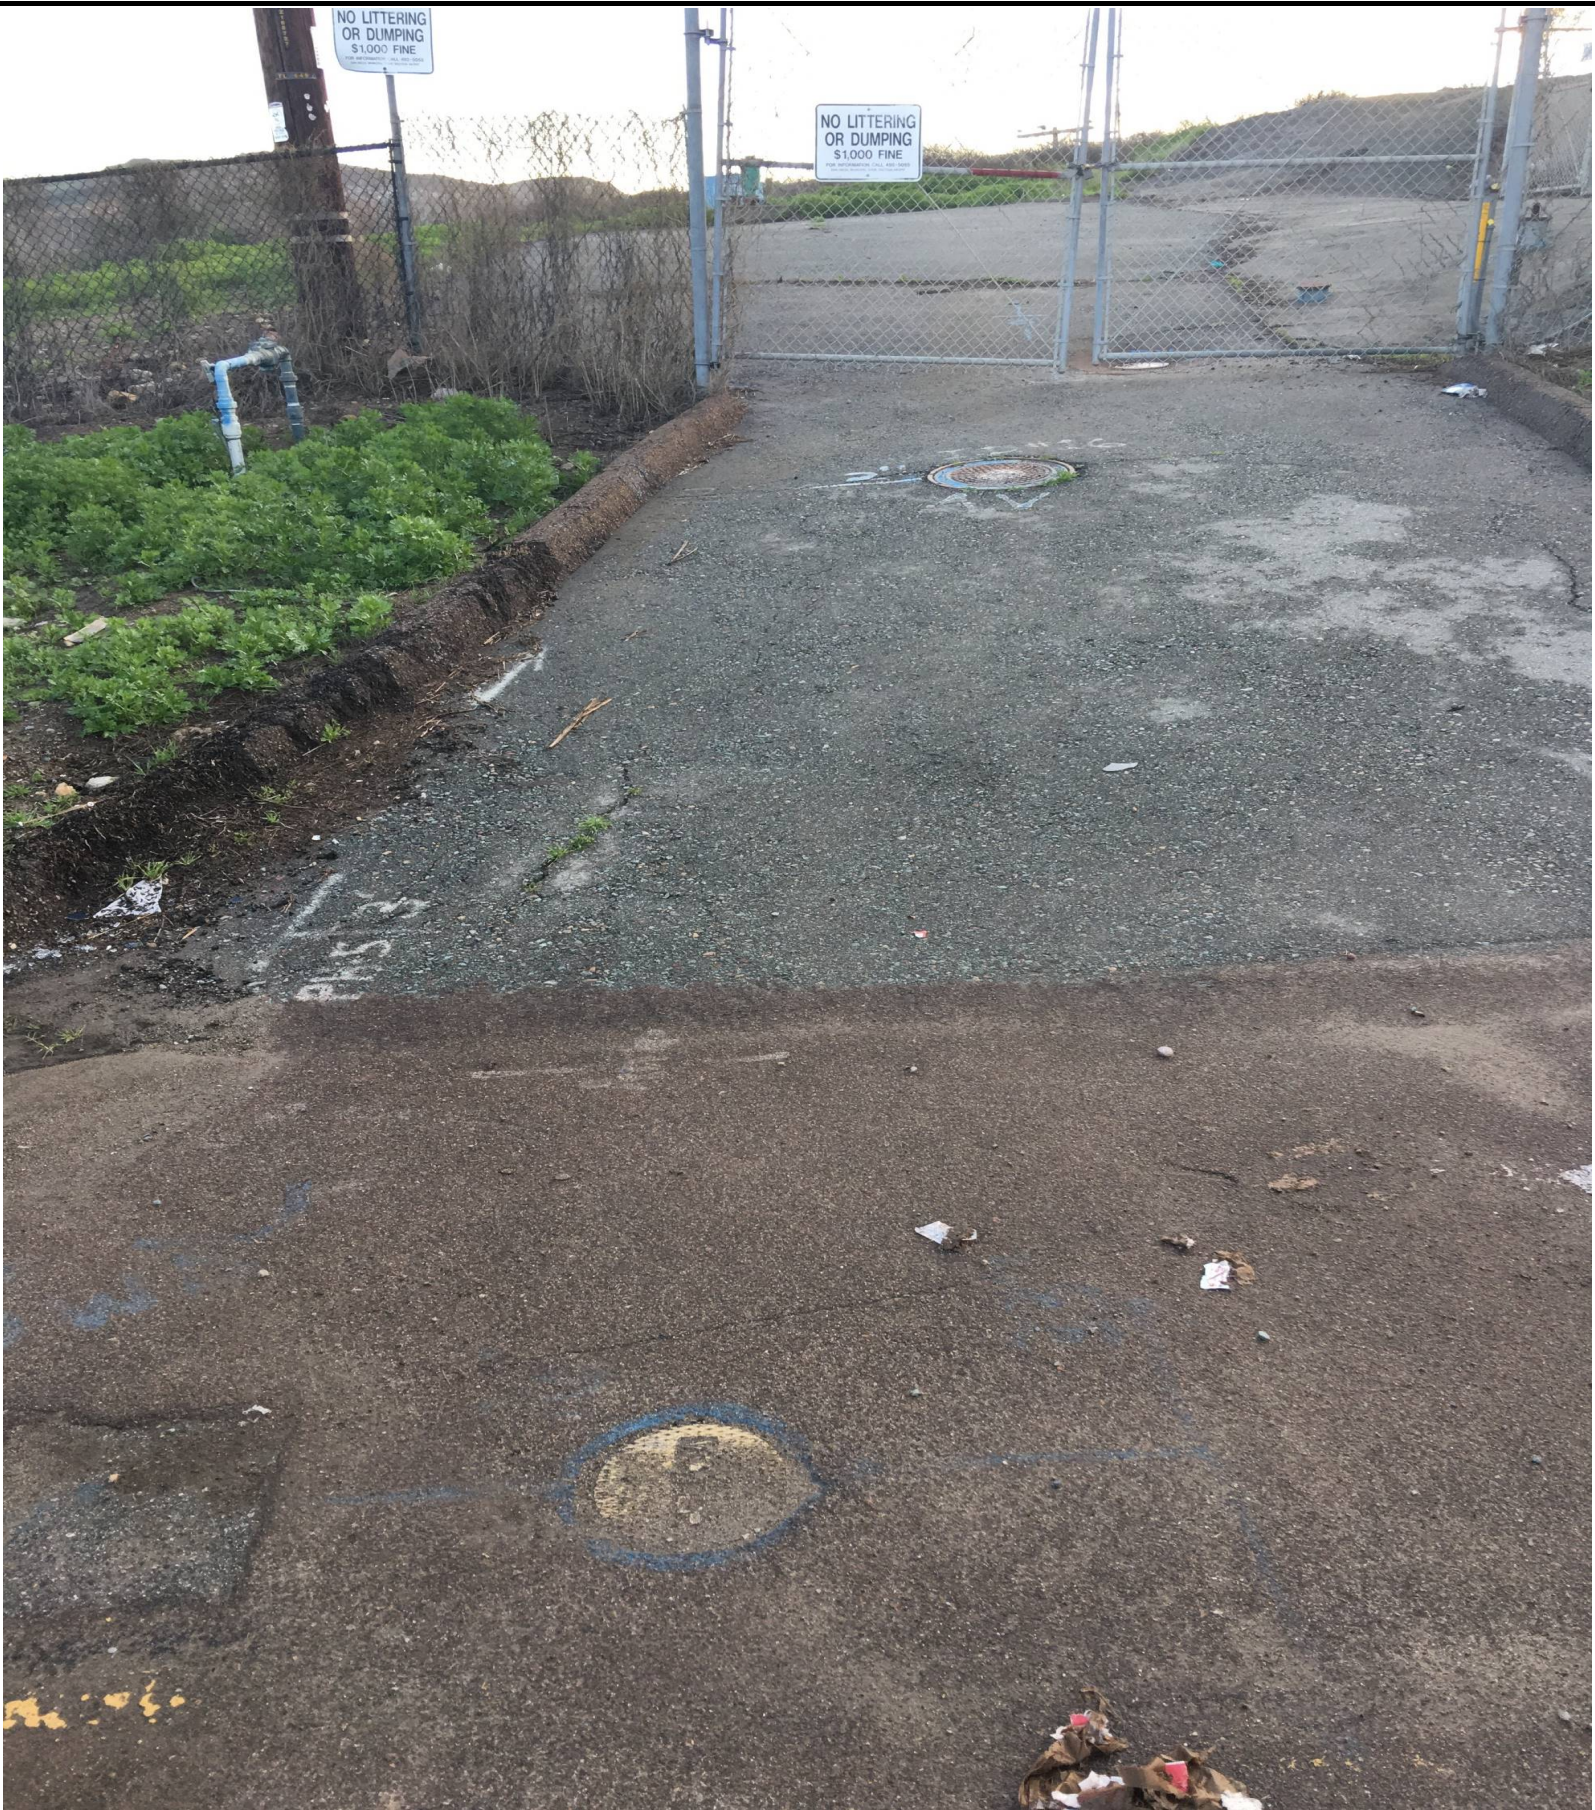
Utility mark out near Pole 18

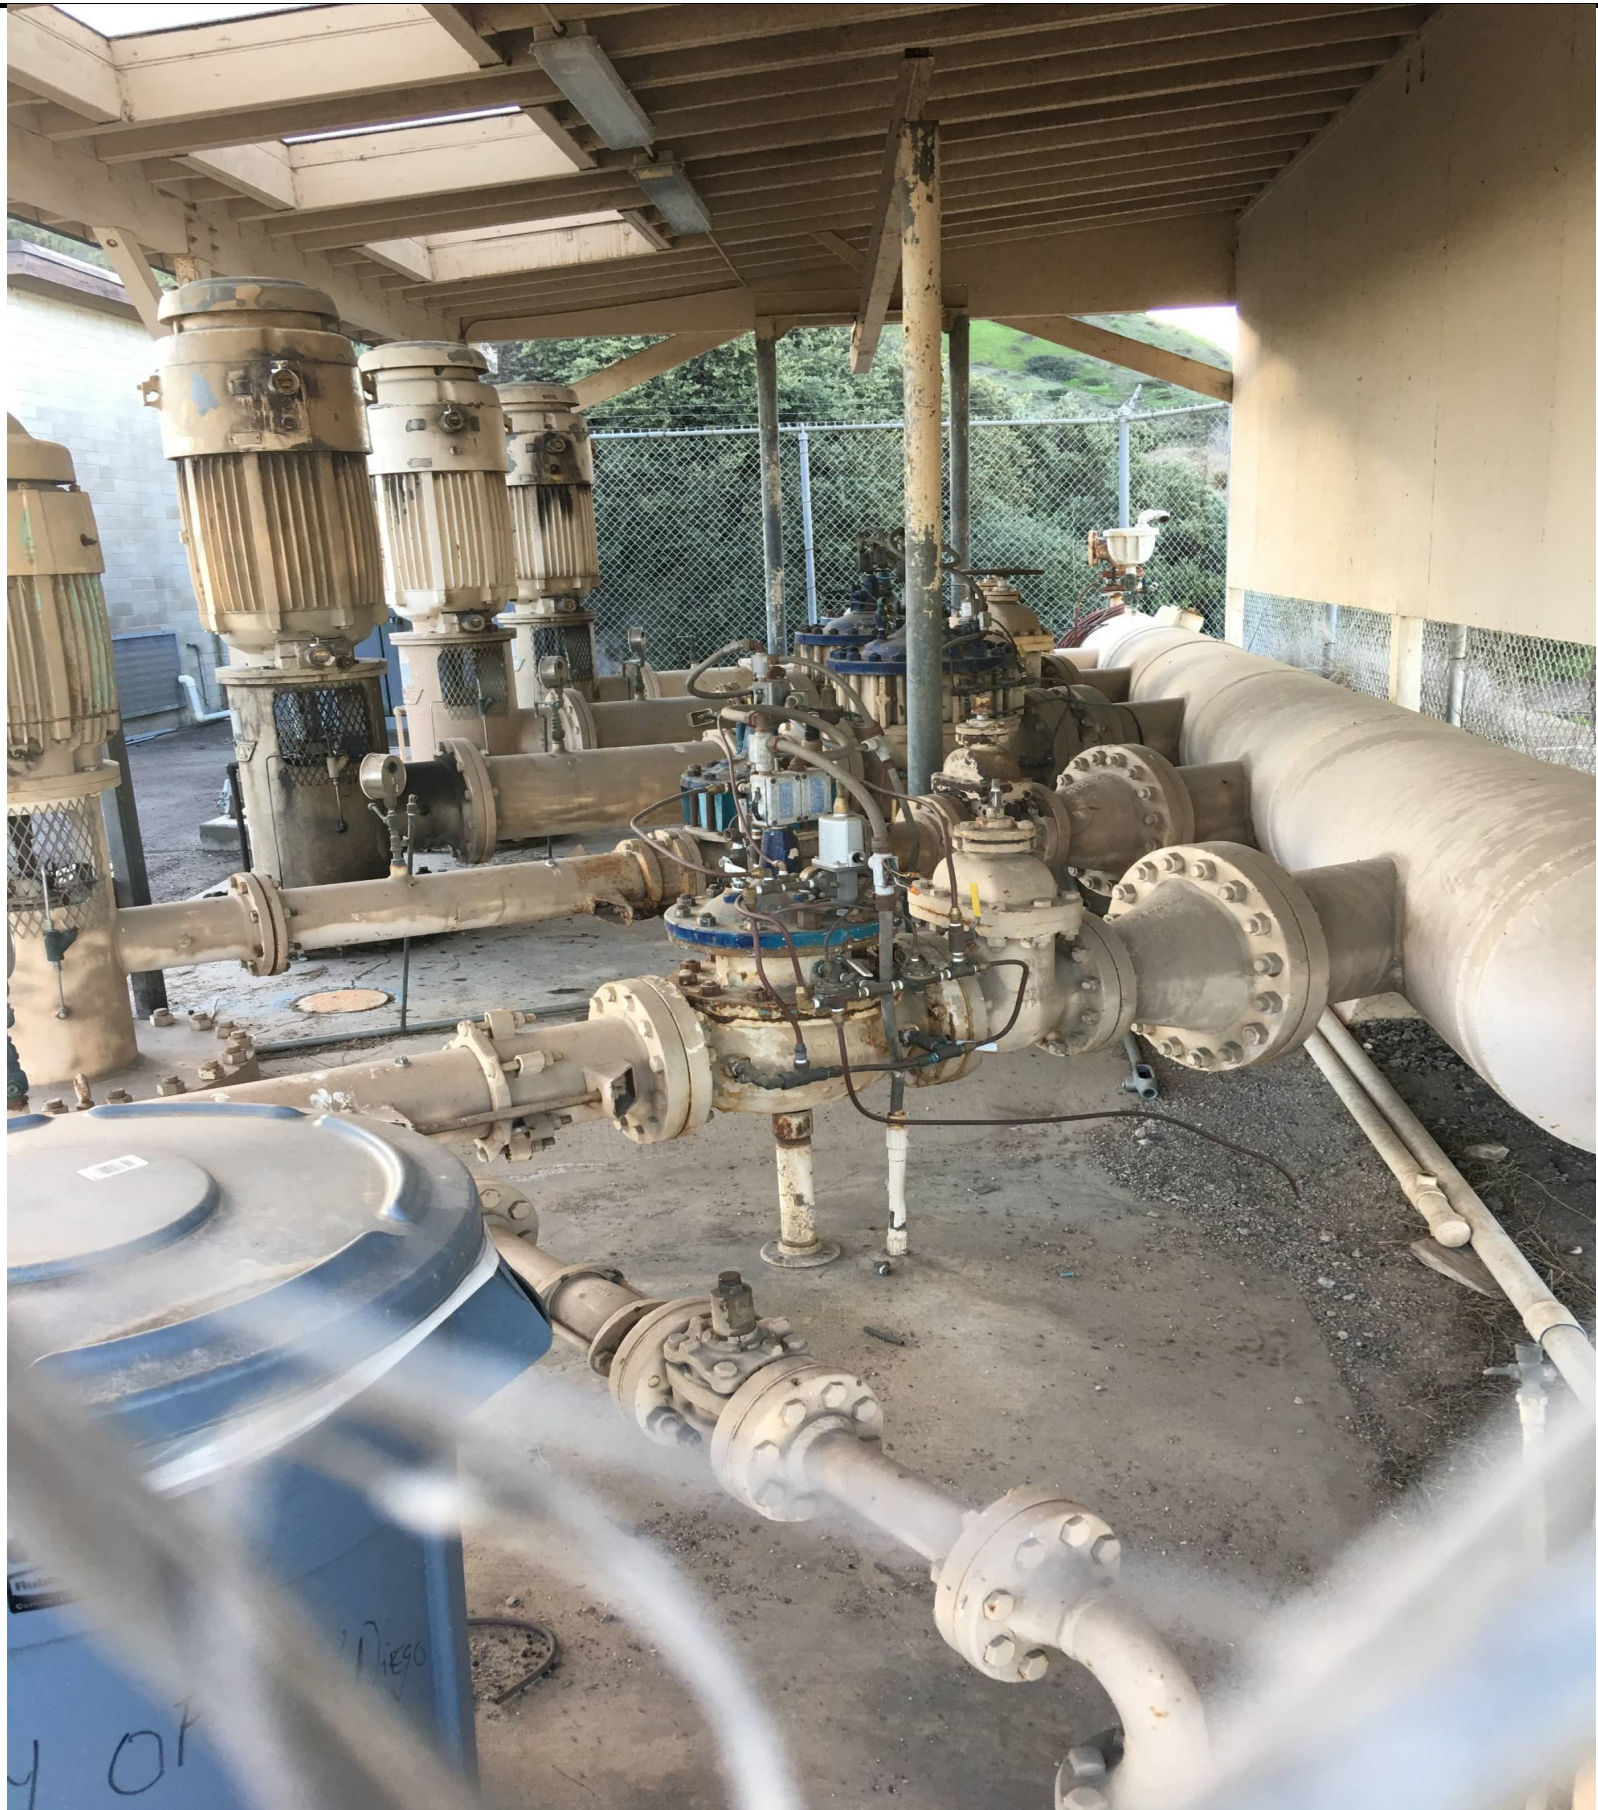
Pipes and pumps inside existing structure

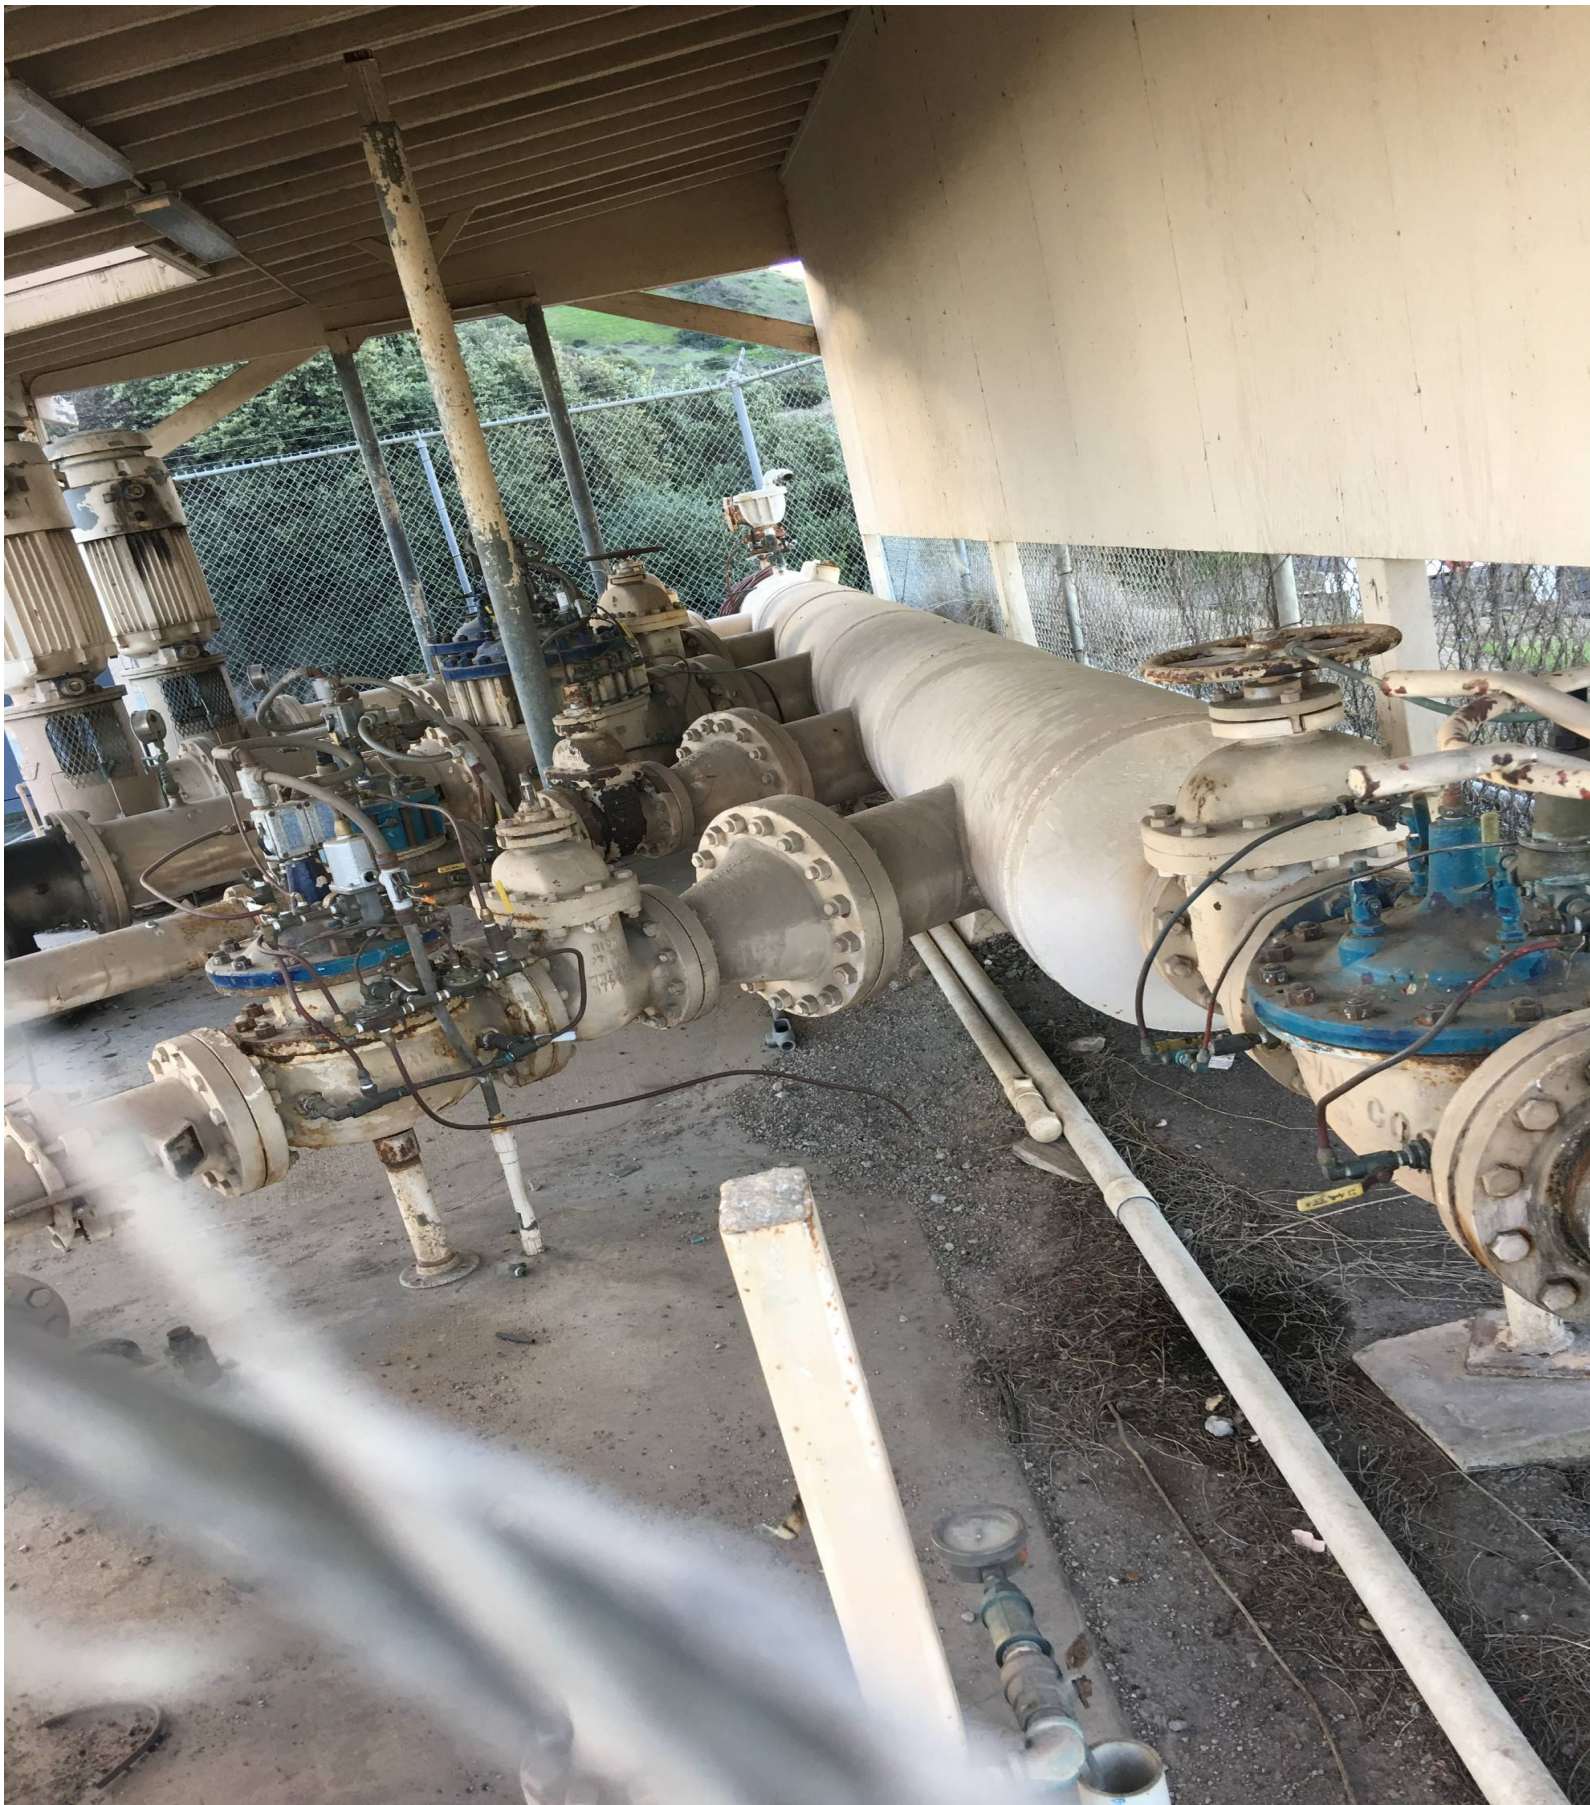
Pipes and pumps inside existing structure

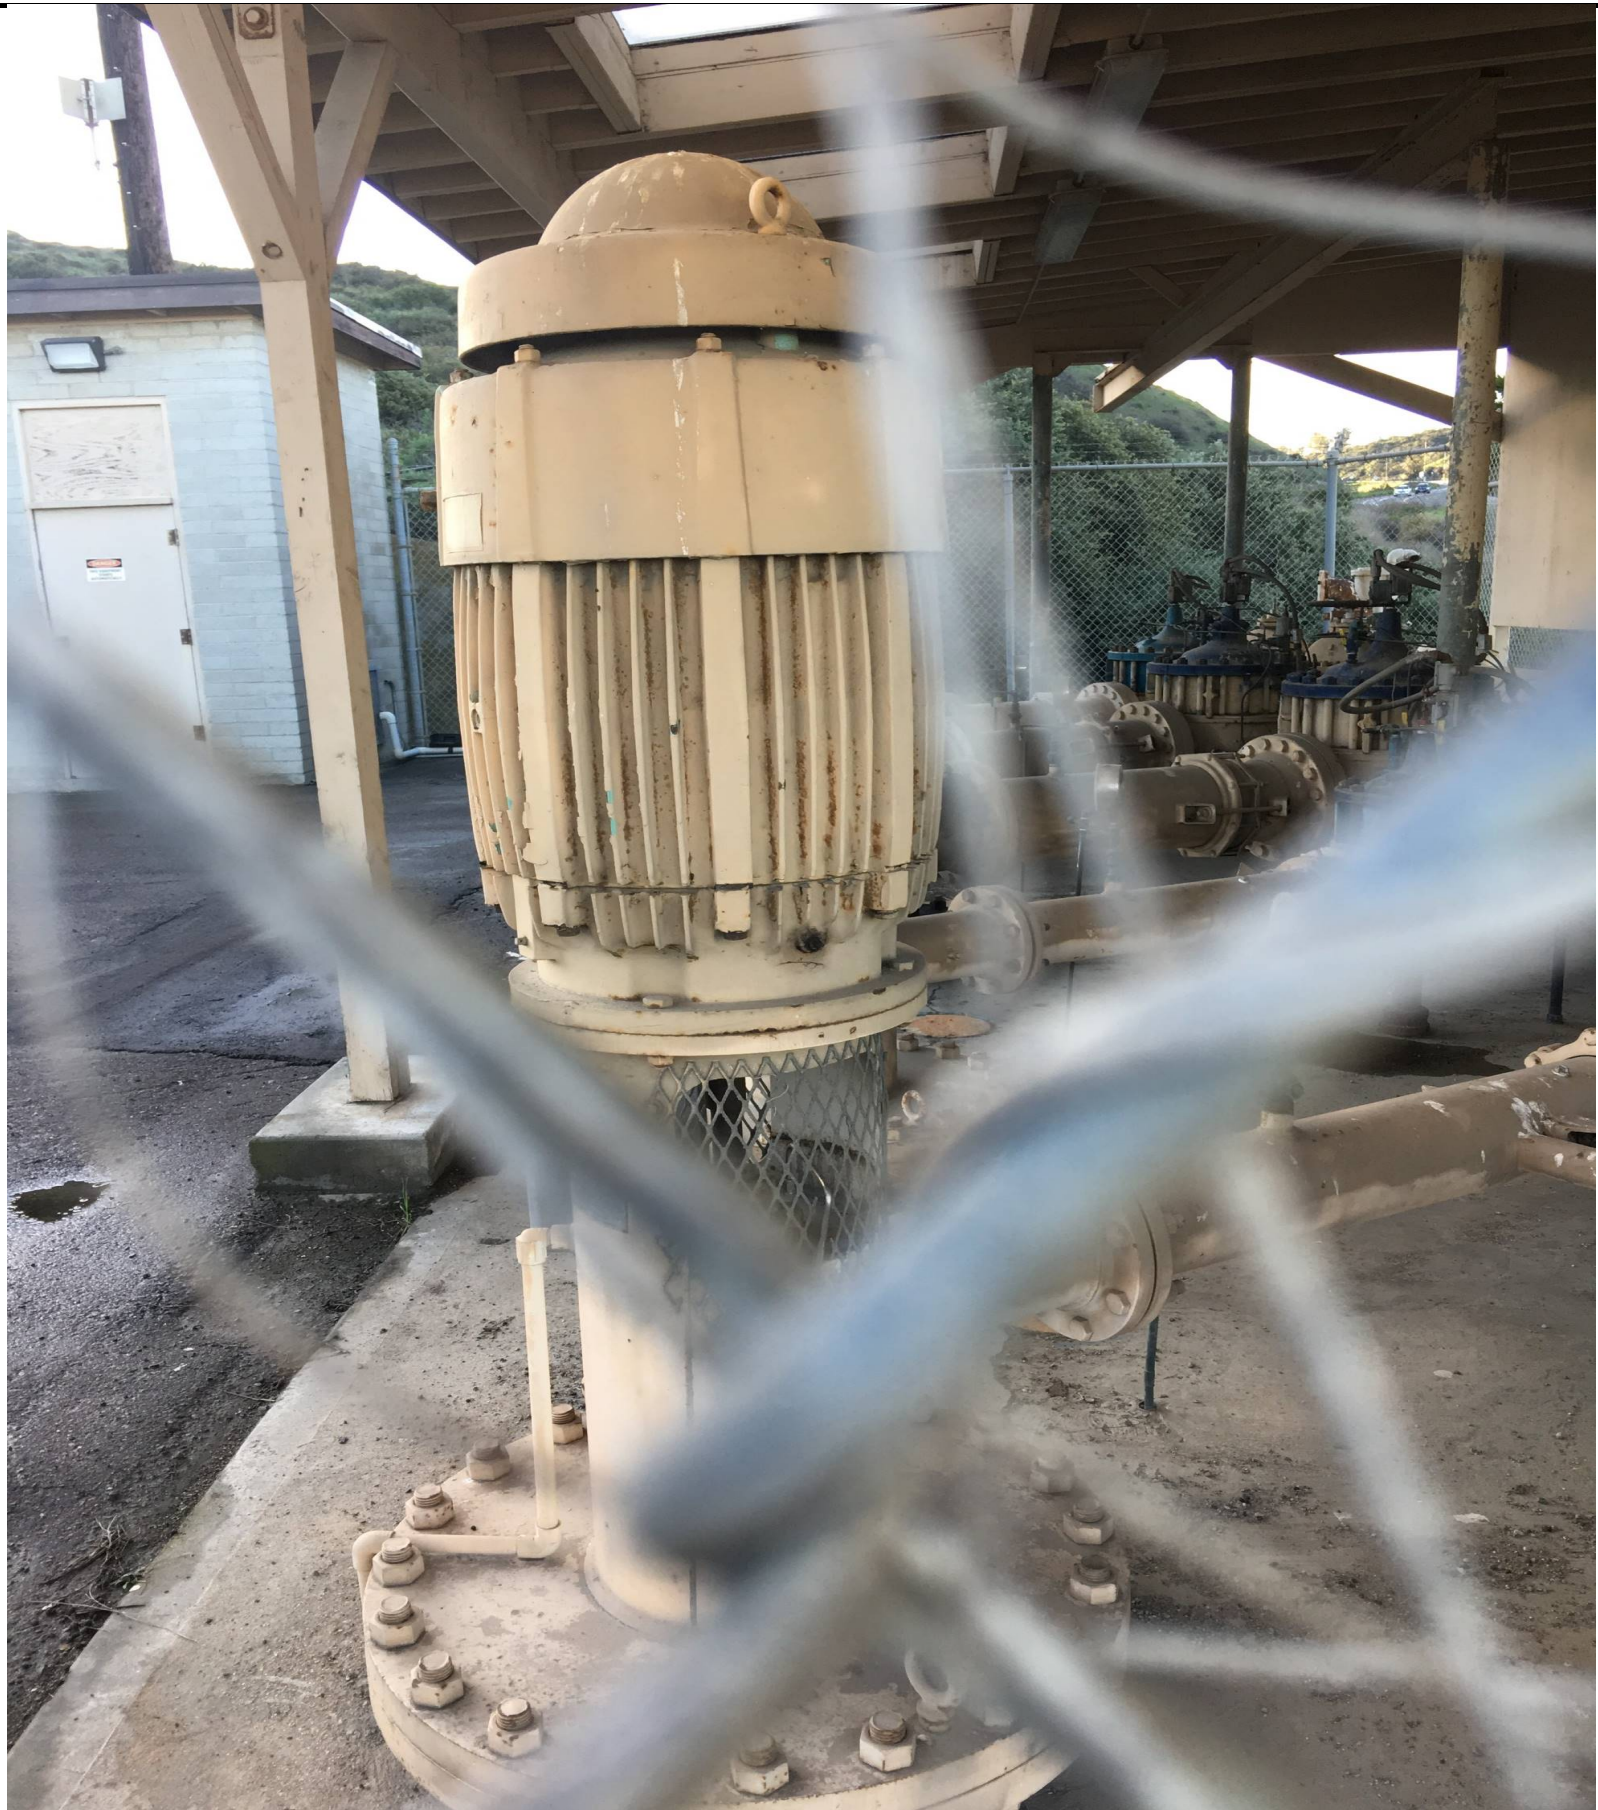
Close up of pump on pipe

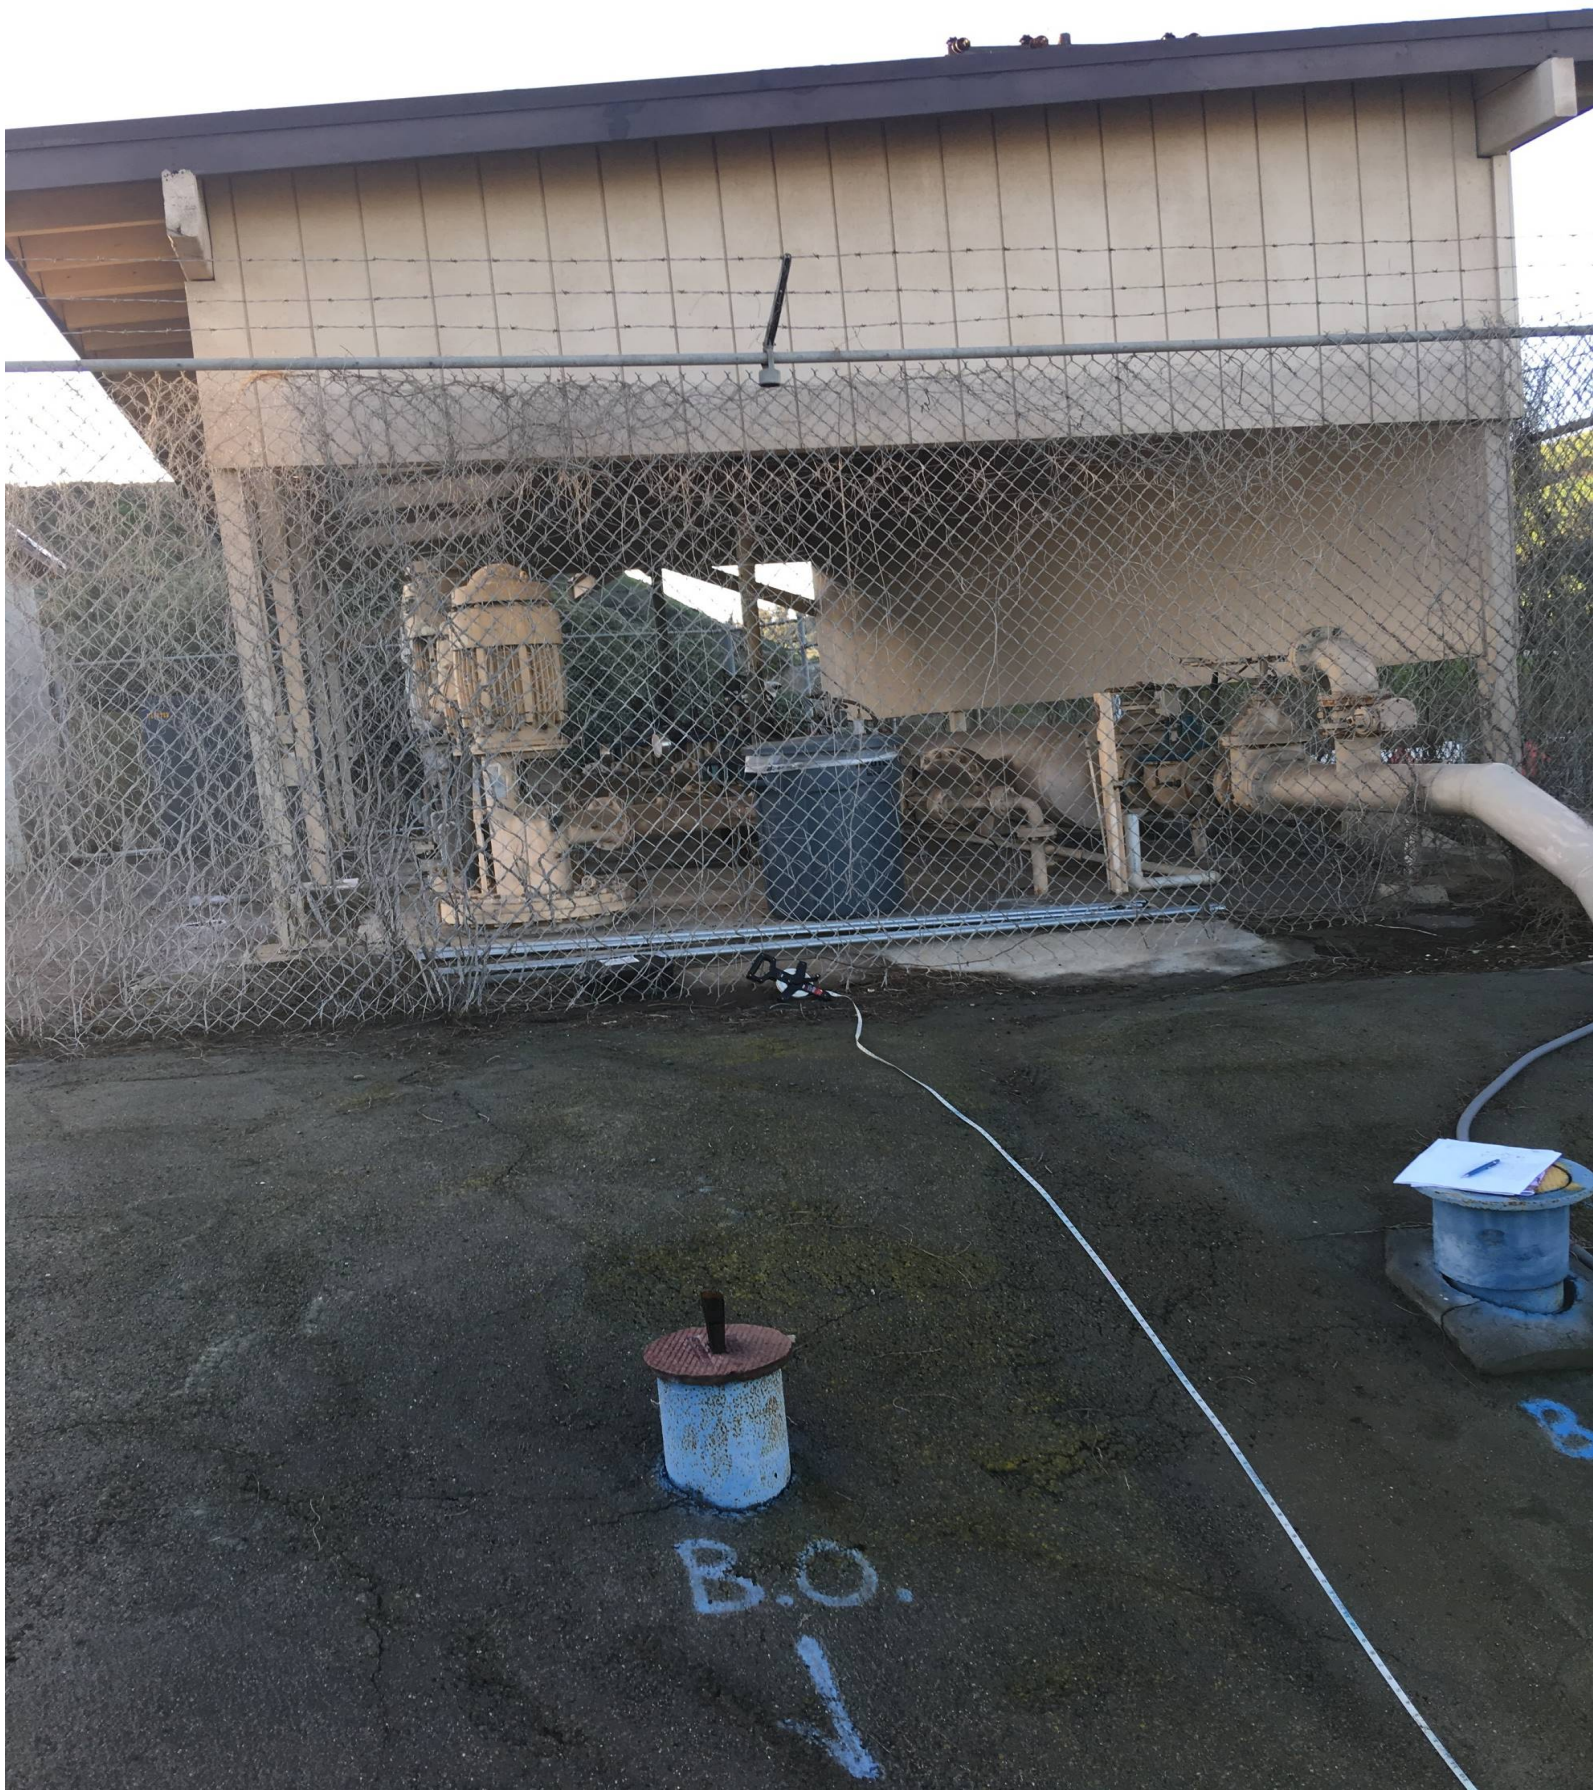
Overall view looking south of structure hosing pipes and pumps

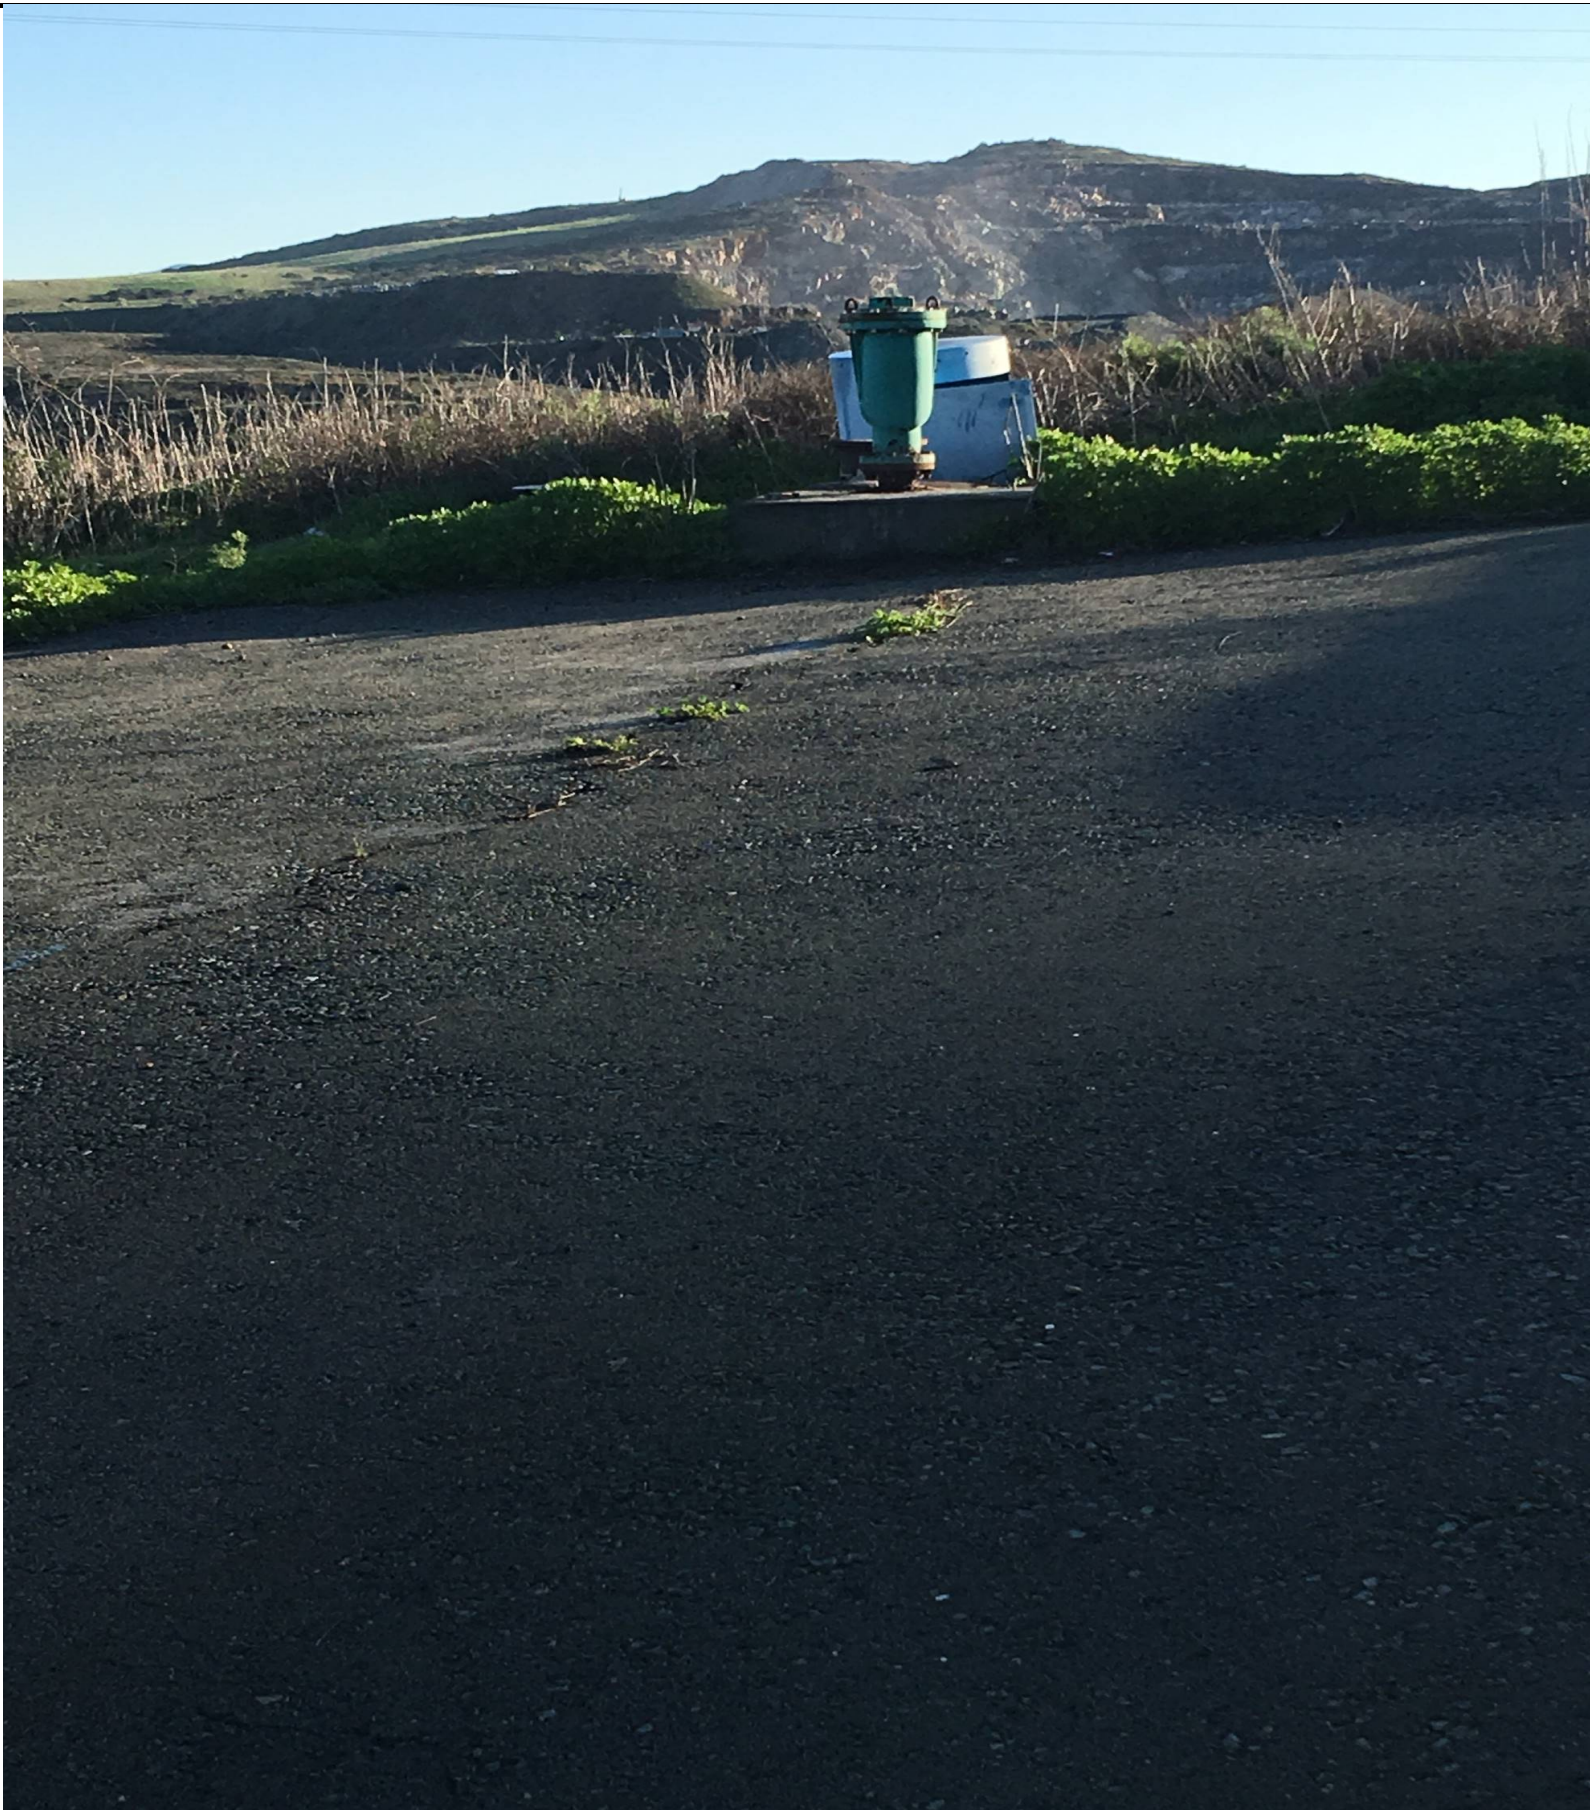
Water utility upslope of Pole 18
